How to Replace a Broken Shear Pin on a Black Jack

Black Jack Trailer Jacks

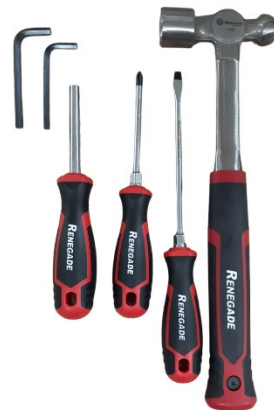
Tools Required

Screw Driver: Phillips Head

Screw Driver Flat Head

Number 5 hex

Number 6 hex

Extension for hex to get leverage.

Small Hammer

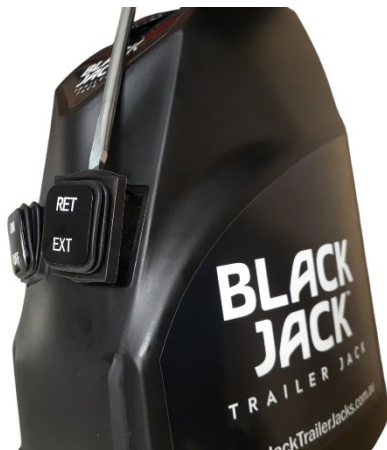
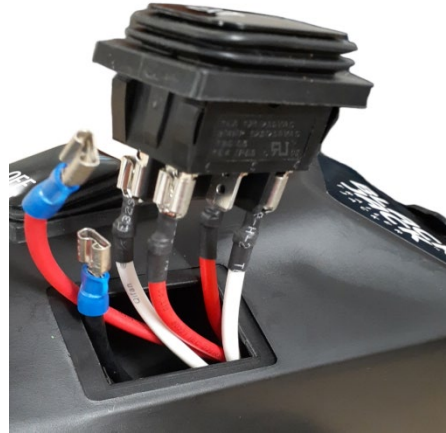
Step 1

Remove the RET\EXT switch, use a flat blade screw driver on the top and bottom of the switch to free the switch from the plastic lugs. (See photo)

When the switch is out, carefully remove the 2 middle wires. There are 3 rows of 2 wires, remove the middle 2, these are the positive and negative wires to the motor. By disconnecting them now, you will have free access to the motor and gearbox later.

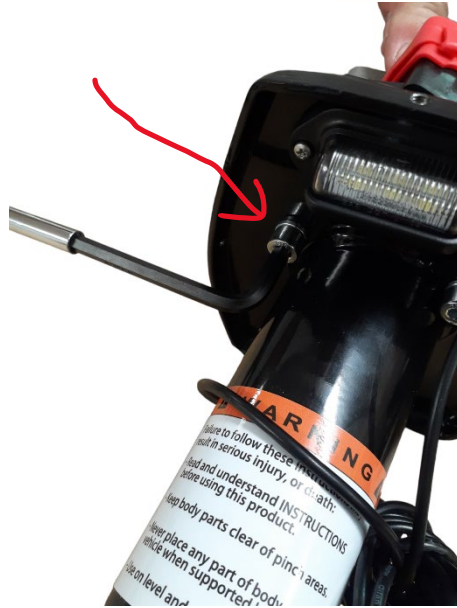
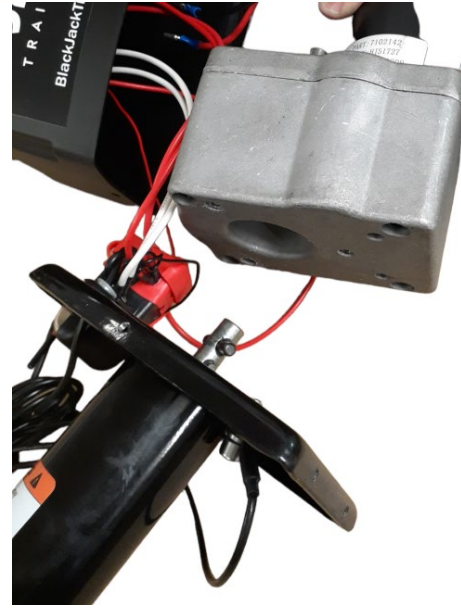
Step 3

Use a number 6 Allen key, key to remove the 3 bolts on the underside of the Black Jack. The bolts are tight so you may need some extra leverage on the Allen key.

Remove the motor and gear box unit from the housing.

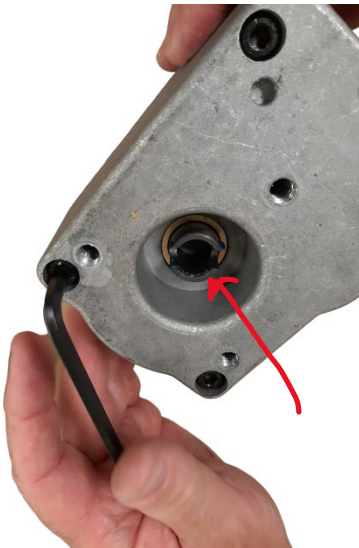
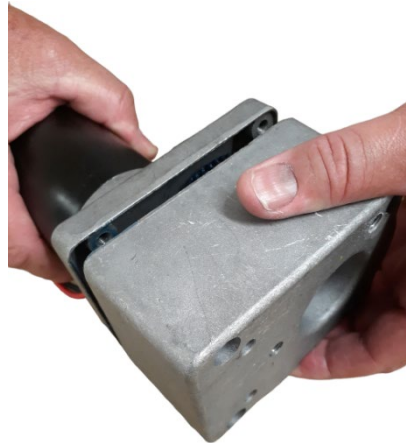
Step 4

Using a number 5 Allen key, unscrew the 4 bolts on the underside of the gear box. These bolts hold the motor and gear box together.

Use a bit of force to separate the gear box from the motor. It is a tight seal, so a bit of force is necessary. The use of a small hammer to tap on the main shaft will help separate the motor and gear box. The main shaft is in the circular recess, give it a gentle tap.

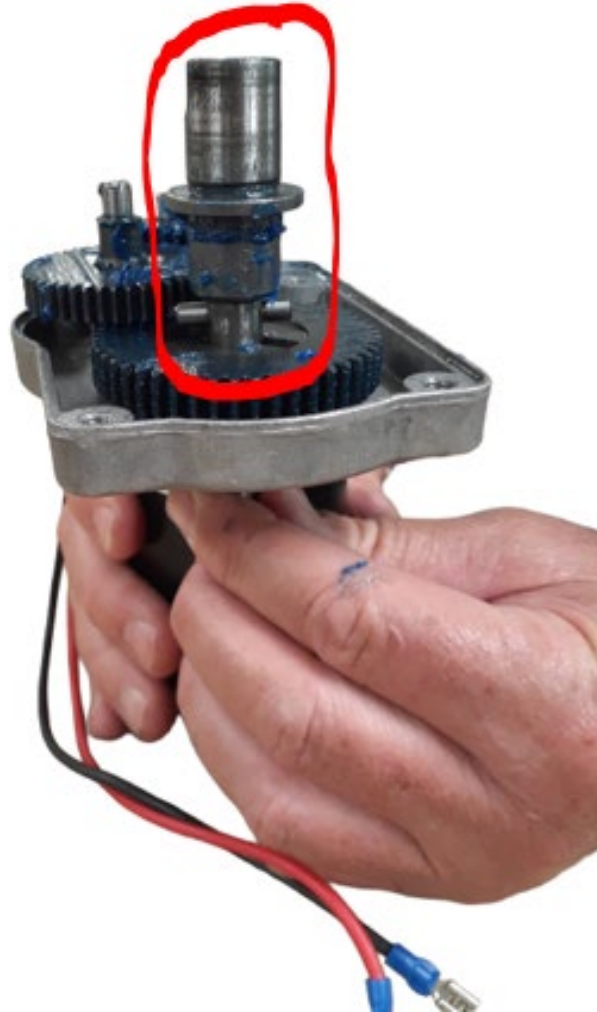
Step 5

Place the gear box on the table and locate the main worm drive shaft as circled below in red. Tap the main worm drive shaft downward with a small hammer until it releases from the main gear drive cog as shown. This will expose the broken shear pin.

Remove all broken pieces as you don't want any metal fragments floating inside the gear box.

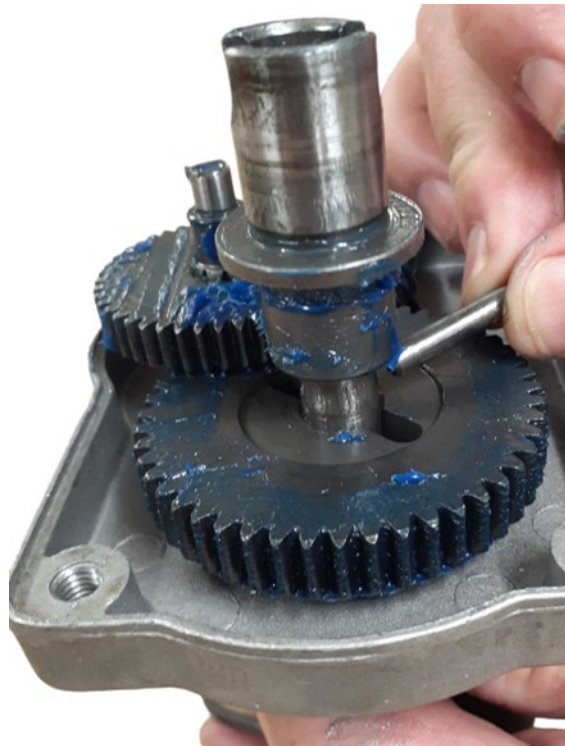
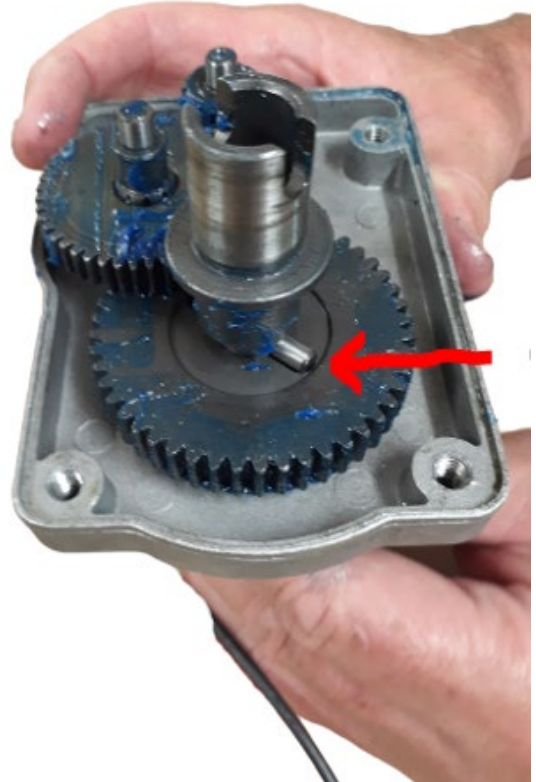
Step 6

Insert the new shear pin into the main worm drive shaft and slide the shear pin down into the groove on the main gear drive cog as shown.
